REPORT NO: NAWCADPAX/TR-2000/59

BREAKDOWN OF PRESERVATIVE FLUID MIL-PRF-46170 IN AIRCRAFT HYDRAULIC SYSTEMS

NAWCADPAX/TR-2000/59
29 March 2001

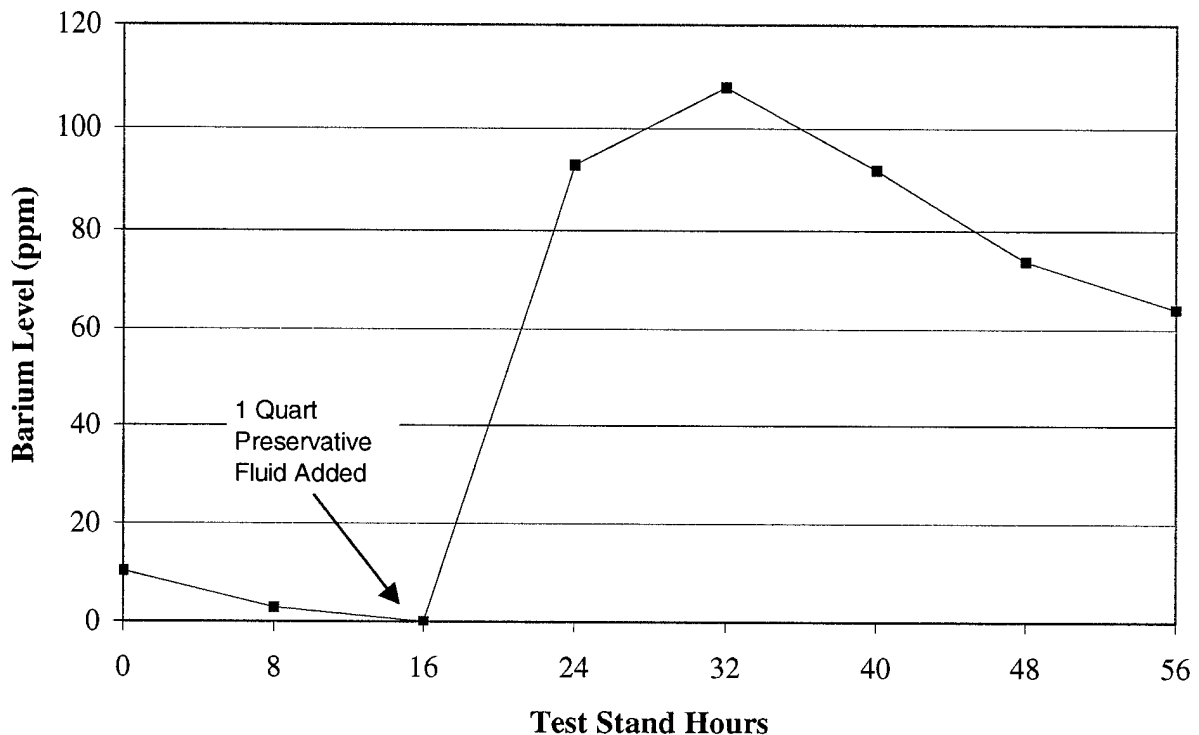
Figure 2: Fluid Barium Level Versus Time

Fluid temperature was maintained at 215°F and the first 2 days of testing were performed without preservative fluid to ensure a clean system. Filter loading for the first 2 days was minimal. Note that fluid barium level was reduced from 13 ppm to 0 ppm in the first 16 hr of testing as residual preservative was removed from system fluid.

The beginning of the third day, 1 qt of preservative fluid was added after 16 hr of operation (shown in figure 2). The rate of filter loading significantly increased after adding the preservative fluid. The level of residual preservative in fluid was steadily reduced as organic material was collecting on the filter.
